Renal pelvic perforation due to double J stent insertion in a nine year old child: An unusual complication of a routinely done procedure

Abstract

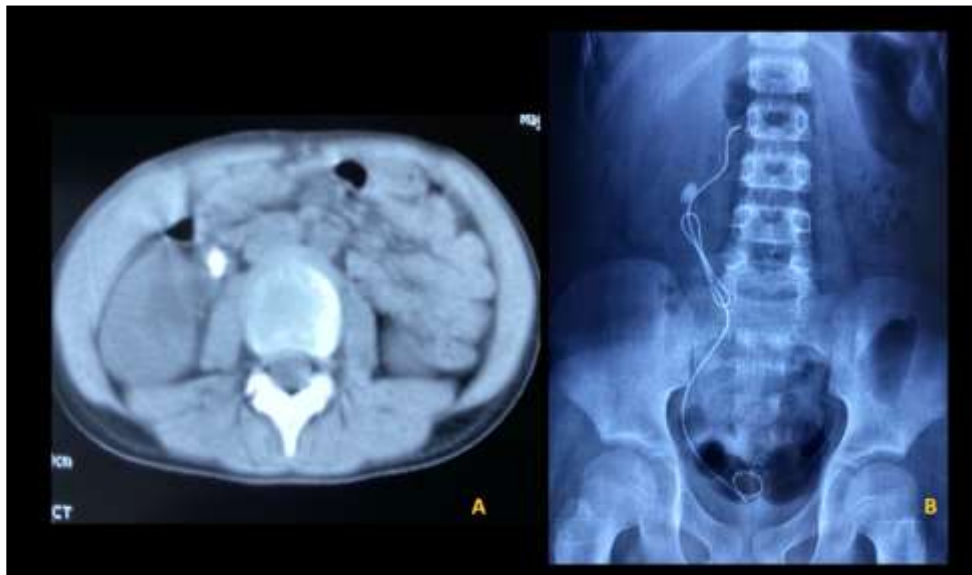
Fig 1: (A) Non contrast CT KUB showing right renal pelvic calculus. (B) X-ray KUB showing proximal tip of DJ stent towards spine at the level of L2 vertebra with loop formation of the stent distal to the calculus.

A 9 year old male child with history of severe right abdominal pain of 1 week duration was referred to us with antecedent history of right double J (DJ) stenting done for the right renal pelvic calculus of 1cm in size. Child was in severe pain and on examination there was tenderness in right iliac fossa and lumbar region. X-ray KUB (Kidney, Ureter, and Bladder) revealed radiodensity at the level of L3 vertebra and a DJ stent with proximal tip towards spine and coiling of stent distal to the calculus. His total leucocyte count was 9800, creatinine was 0.6mg/dl, urine analysis was normal.

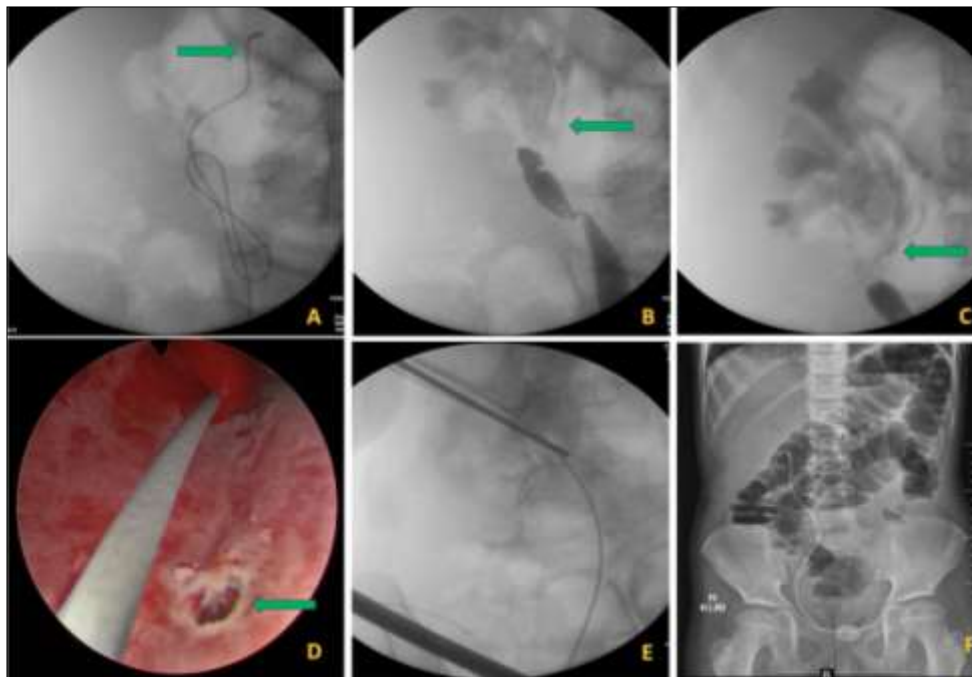
Fig 2: (A) Fluoroscopic image of malposition of DJ stent (arrow). (B & C) Contrast extravasation into false passage outside pelvis of the kidney (arrows). (D) Posterior renal pelvic wall perforation nephroscopy view (arrow). (E) Antegrade DJ stenting. (F) Postoperative X-ray KUB showing complete removal of calculus with DJ stent in situ.

Informed consent was taken from child parents for repositioning of the stent and right mini PCNL (percutaneous nephrolithotomy). Under general anesthesia after removing the DJ stent retrograde pyelogram (RGP) was done and false passage was delineated parallel to renal pelvis. Retrograde placement of guidewire was not possible. Supine Percutaneous renal access was gained through middle calyx and tract dilated to 20Fr. After removing the calculus, posterior renal pelvic wall perforation noted, confirming renal pelvic perforation during initial stent placement. Antegrade DJ stent placed and child discharged on postoperative day two. DJ stent removed after 6 weeks and the child is under follow up since 3 months.

Probable reasons for this unusual complication leading to morbidity of the child in this case includes (i) DJ stenting done without fluoroscopy guidance (ii) using undue pressure while passing guide wire against resistance at level of calculus resulting in perforation of renal pelvic wall which was already weakened by edema and inflammation by the impacted calculus (iii) not confirming position of DJ stenting postoperatively.
